# RESTORATION STRATEGY FOR THE MERCED RIVER THROUGH YOSEMITE VALLEY

v4.0 2/06/2017

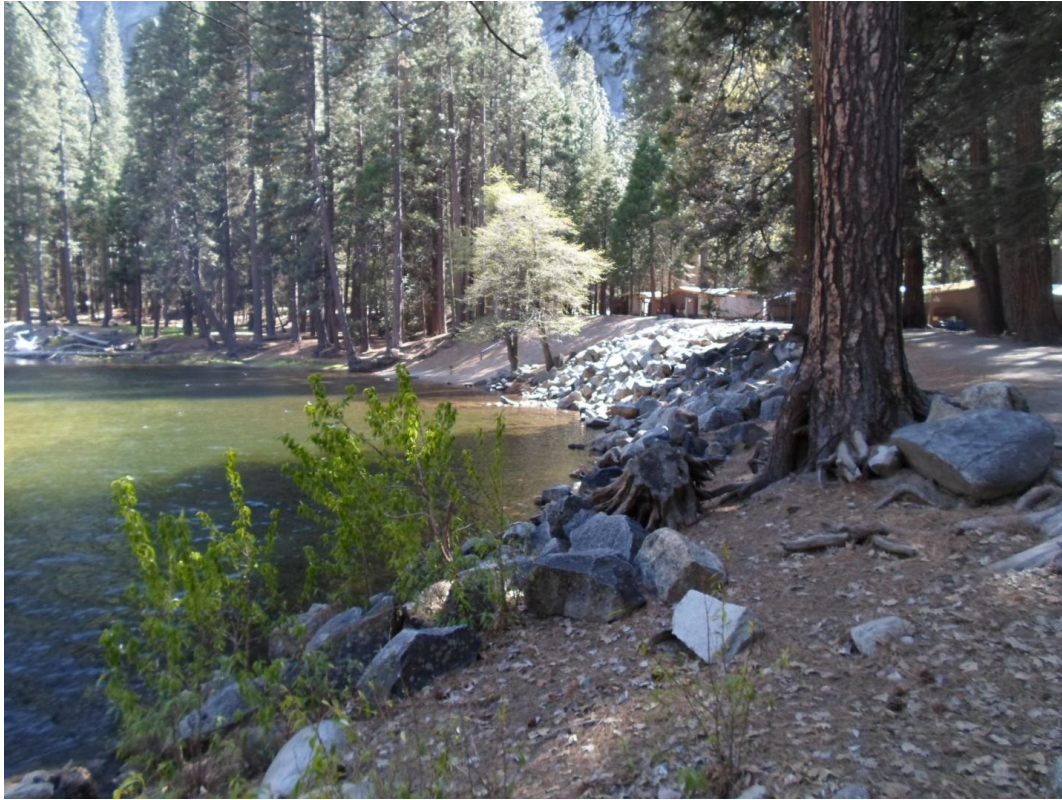
**Bank armoring adjacent to Housekeeping Camp (river flow is towards the camera).**

- **Restoration of dynamic river and tributary channels in Yosemite Valley**, important to allow the development of diverse, complex riparian habitats supporting successional vegetation in multiple stages. While processes such as channel migration and development of cut-off channels and meander belts undoubtedly affected the entire valley in prehistoric time, they can no longer have unfettered access to the entire landscape. The current constructed constraints on river-channel activity (e.g., armored banks), however, are more severe than strictly required by limitations of infrastructure, and they undoubtedly compromise the natural form and function of the river.

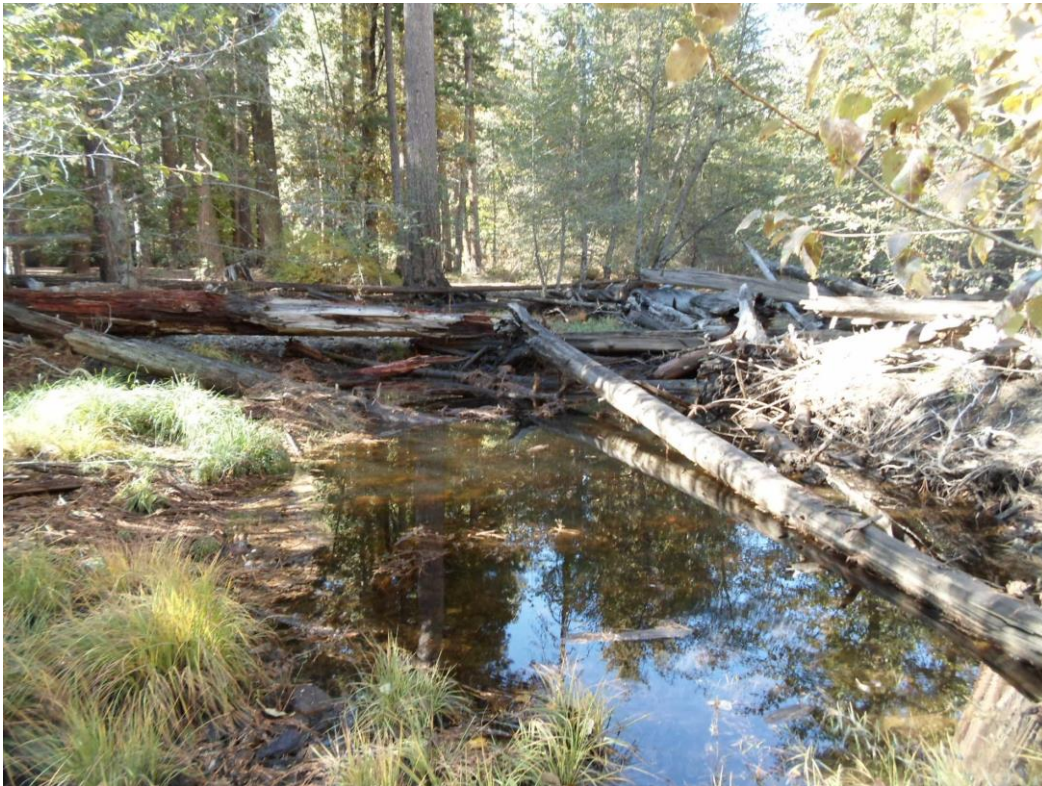
**Side channel trending west off the mainstem Merced River, just upstream of Sugar Pine Bridge.**

- **Encouragement of more frequent overbank flooding**, supporting a more natural and diverse assemblage of riparian plant species and thus improved riparian habitat for birds, amphibians, and mammals. This approach works in consort with others: overbank flooding encourages the development and expansion of tributary channels, and a dynamic river will invariably leave local areas more prone to overbank flows at lower discharges. Therefore, this approach is also subject to the same types of constraints to achieve a balance between expression of natural riverine processes and their enjoyment by visitors.

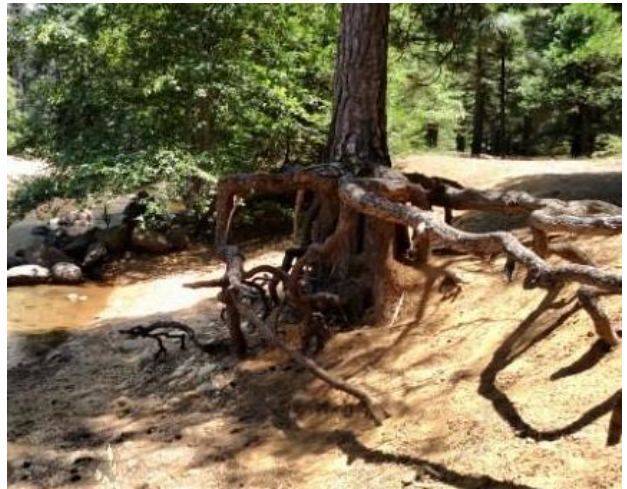
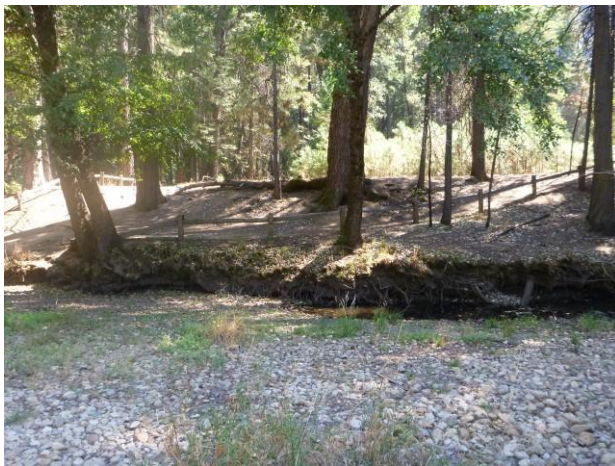
**Views of bank erosion. Clockwise from top left: downstream of Clarks Bridge, the riverbank along Upper Pines campground, along lower Tenaya Creek, between Stoneman Bridge and Housekeeping Camp**

**Restoration of the riparian zone**, including the reconstruction of streambanks trampled by unrestricted visitor access and reestablishment of a more diverse, native-species riparian vegetation community. As with the active re-creation of in-channel habitat, natural processes of vegetation succession and geomorphic adjustment would eventually achieve many of these goals, but the period of recovery without active intervention would likely extend for many decades or centuries.

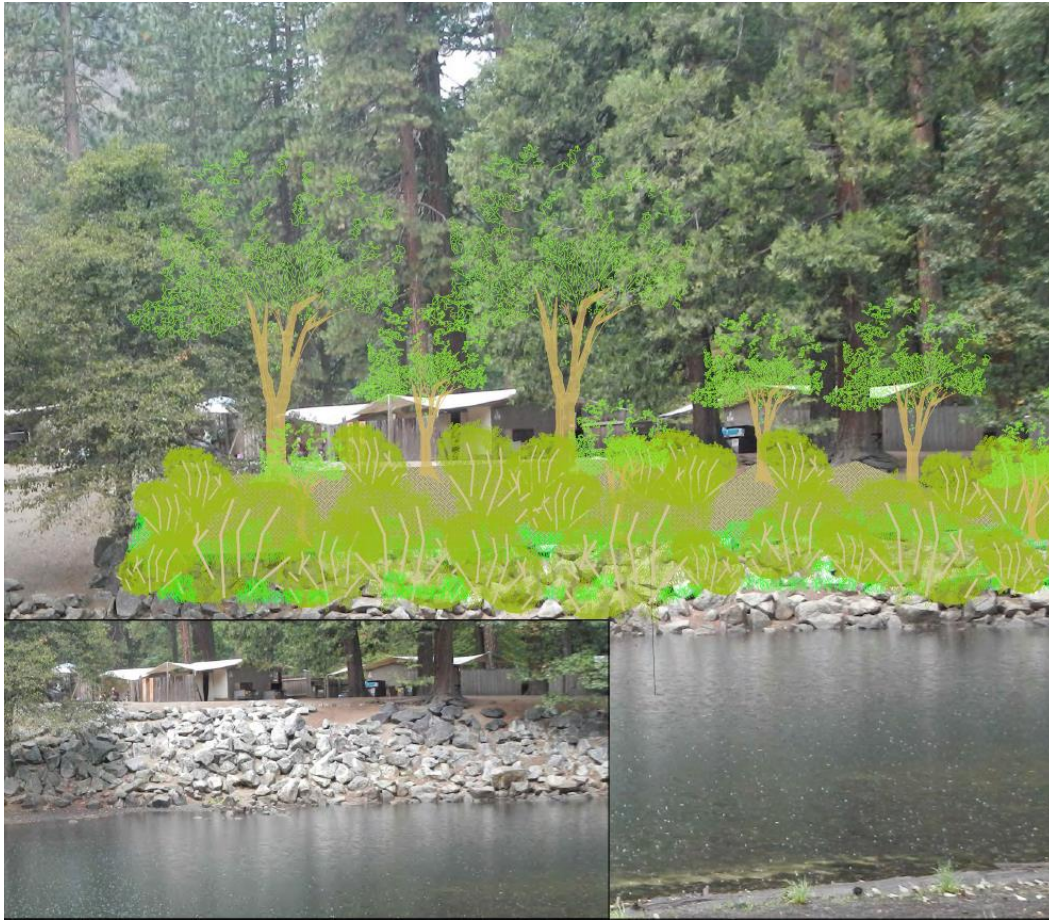
Full or partial riprap removal and vegetation replanting to create a more diverse riparian zone:

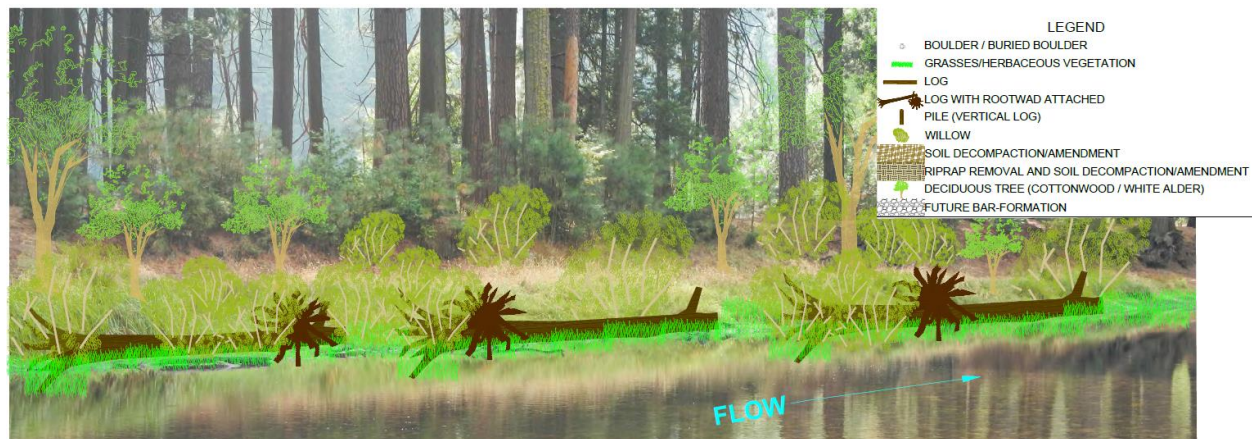
Channel-narrowing treatment along trampled banks:
